Re: Inspection Report and Sampling Results
RCRA Compliance Evaluation Inspection – Land and Lakes, 2000 East 122nd Street,
Chicago, Illinois

COMPLIANCE EVALUATION INSPECTION REPORT

INSTALLATION NAME: Land and Lakes Company

DATE OF INSPECTION: June 16, 2011

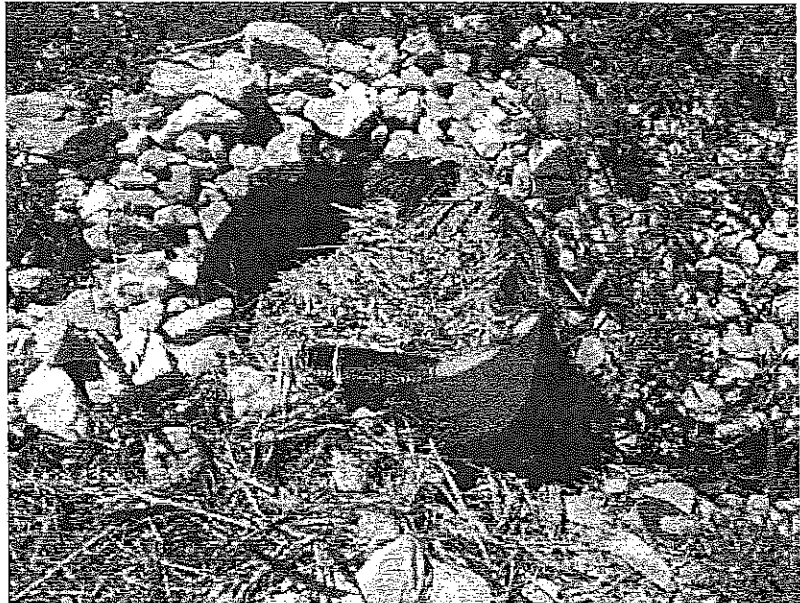
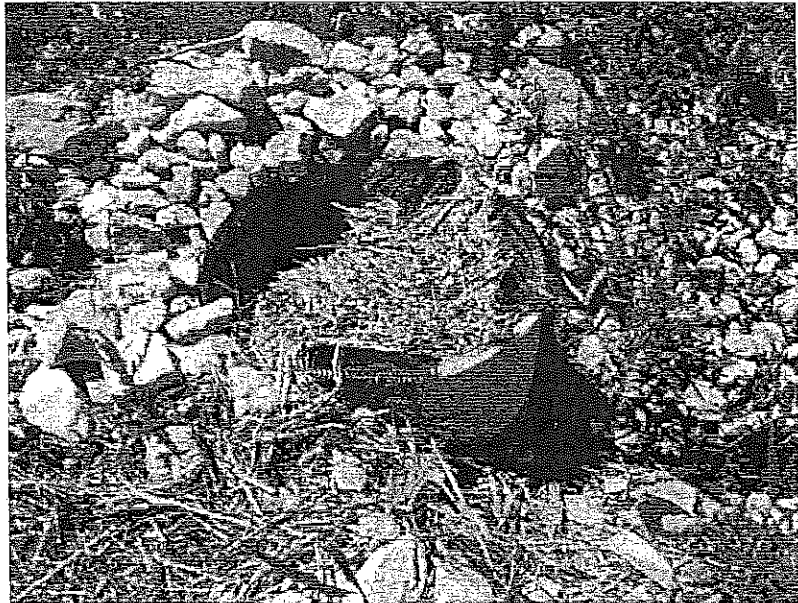
Disk Number 1
Photo Number 1
Photo Filename DSCN0151.jpg
Date/Time 6/16/2011
11:03:16 AM
Photographer Jamie Paulin and
Lynne Roberts

We viewed Land and Lakes property, Outfall 003, located on the South side of the property. A cover net, along with some grass, was covering the pipe. A small amount of water was flowing

from the North heading south to the pipe, at the time of the inspection. Samples were not taken from Outfall 003 since it did not flow into Dockside's Outfall 002. *See, photographs 1 and 2.*

Land and Lakes property, Outfall 003, located on the South side of the property. A cover net and grass were covering the pipe and a small amount of water was flowing east to the pipe at the time of the inspection.

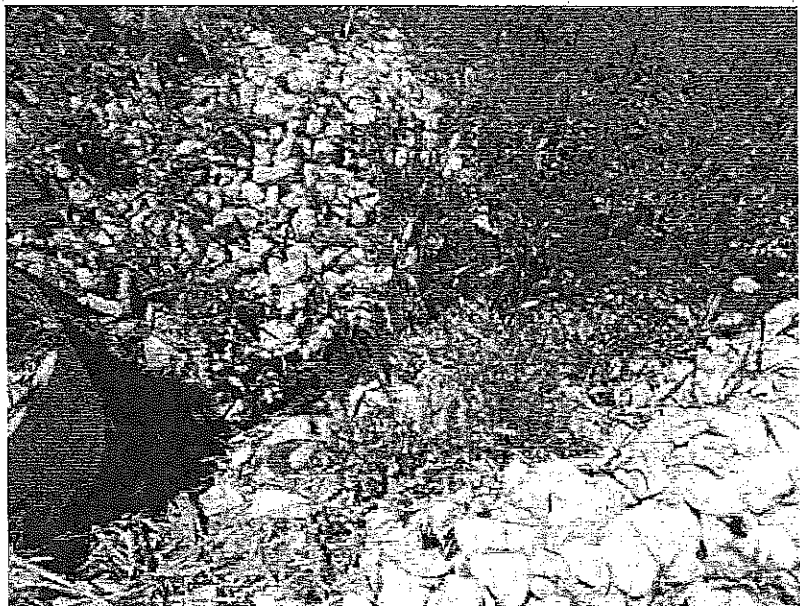
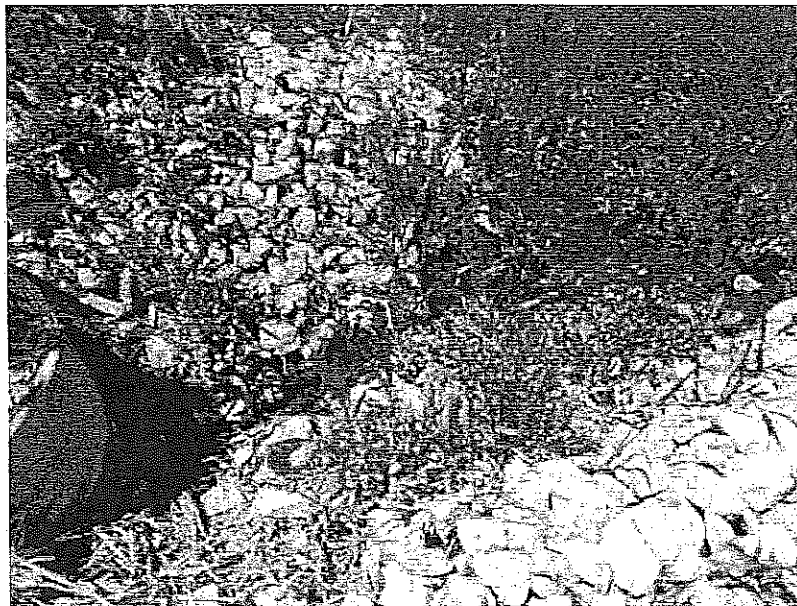
Disk Number 1
Photo Number 2
Photo Filename DSCN0152.jpg
Date/Time 6/16/2011
11:03:22 AM
Photographer Jamie Paulin and
Lynne Roberts

Land and Lakes property, outfall 003. A small amount of water was flowing east to the pipe at the time of the inspection.

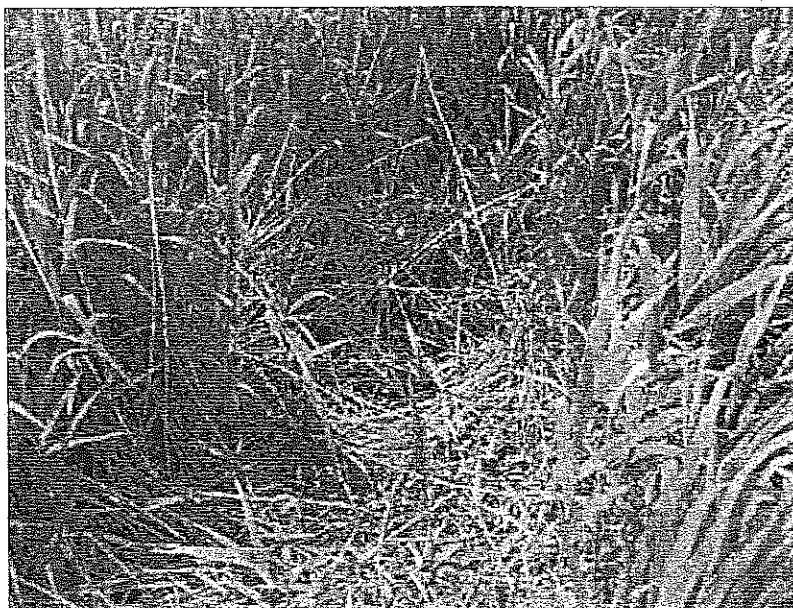
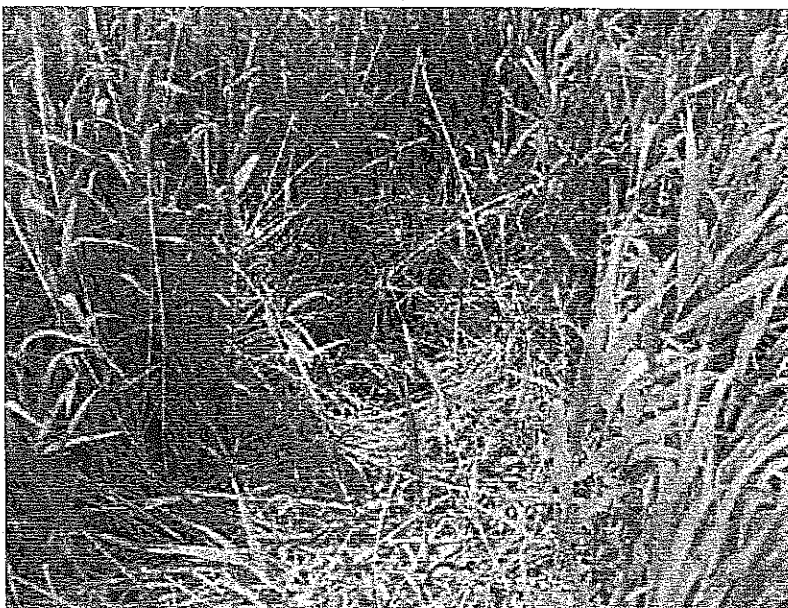
Disk Number 1
Photo Number 4
Photo Filename DSCN0154.jpg
Date/Time 6/16/2011
11:49:56 AM
Photographer Jamie Paulin and
Lynne Roberts

We then traveled to Land and Lakes Outfall 002, located on the West side of the property. Mr. Lukowich found where the Outfall travels into a grate. However, at the time of the inspection, Land and Lakes did not actually know to where the water flowed after leaving the outfall. I sampled from this grate where the water was flowing from Outfall 002. *See, photograph 4.*

Land and Lakes Outfall 002, located on Land and Lakes property. A steady flow of water was flowing to the outfall. This outfall was located across the street from Dockside. Land and Lakes did not know where the water went once it left the outfall.

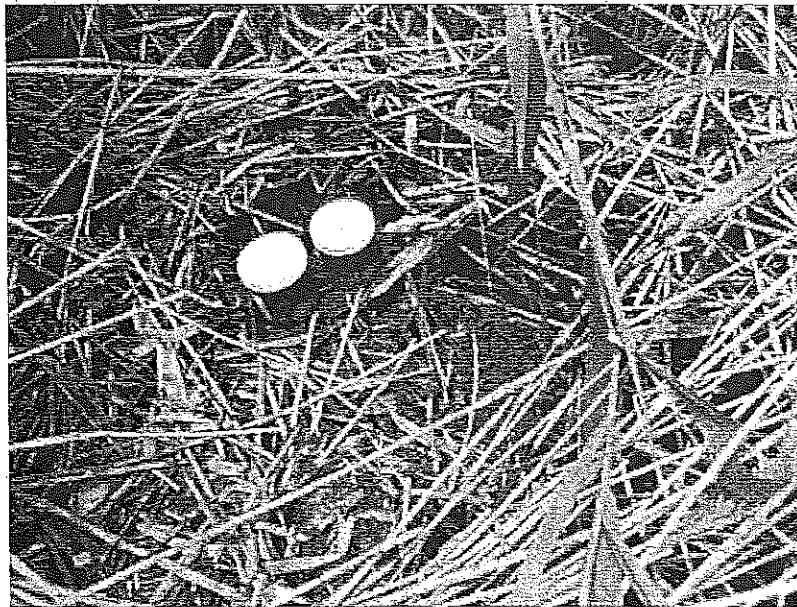
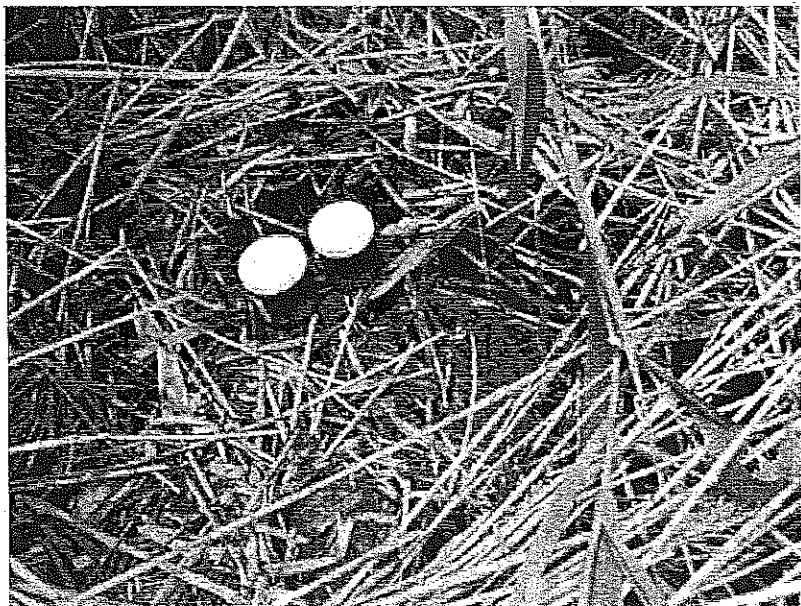
Disk Number 1
Photo Number 6
Photo Filename DSCN0156.jpg
Date/Time 6/16/2011
12:24:50 PM
Photographer Jamie Paulin and
Lynne Roberts

I then used a disposable scoop and distributed the flowing water, alternately, into two separate jars. Land and Lakes had requested split samples. The samples were taken at 1:20pm. We labeled the samples as SRL-002A and SRL-002A split. The split sample was given to Land and Lakes. *See, photograph 6.*

SRL-002A and SRL-002A split. Two samples collected from Land and Lakes outfall 002. The color of the collected water was yellow/amber. The split was given to Land and Lakes.

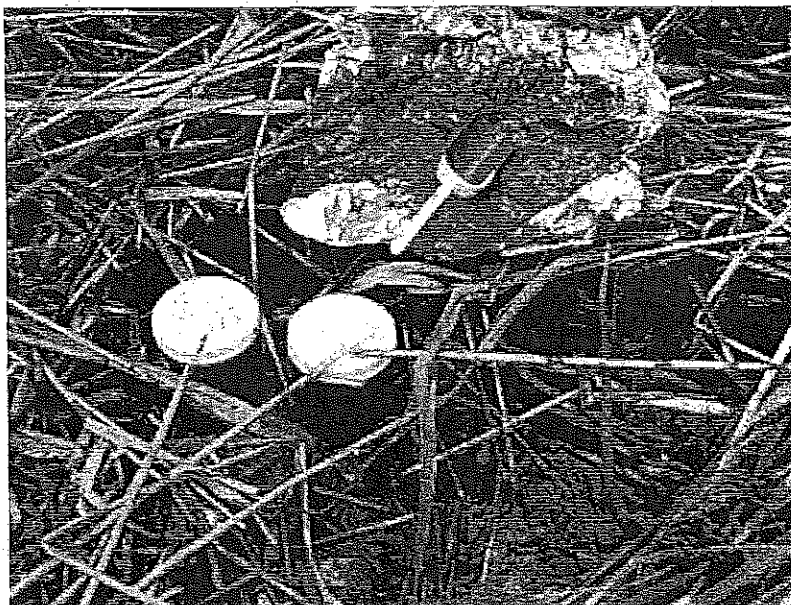
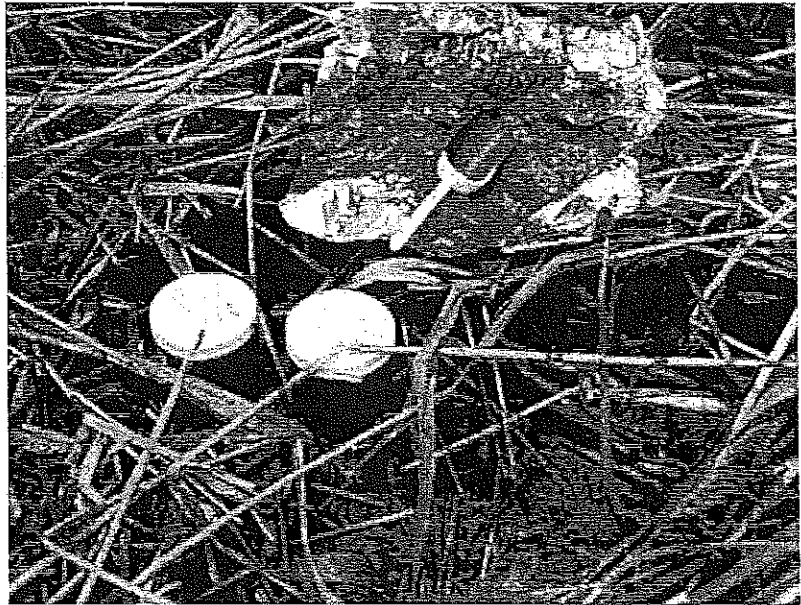
Disk Number 1
Photo Number 7
Photo Filename DSCN0157.jpg
Date/Time 6/16/2011
12:36:32 PM
Photographer Jamie Paulin and
Lynne Roberts

Lastly, I was able to take sediment samples from this same location. I collected the sediment material with a disposable scoop and composited the sediment onto a piece of aluminum foil. I then alternately distributed the material into two separate jars. The sample was taken at 1:30pm. We labeled the samples as SRL-002B and SRL-002B split. The split sample was given to Land and Lakes. *See, photograph 7.*

SRL-002B and SRL-002B split. Two samples collected from the sediment located at Land and Lakes outfall 002. The color of the collected sediment was brownish/gray. The split was given to Land and Lakes.
